Re: 2010 Year End Report - Aquatic Management Program at Spy Pond – Arlington, MA

In 2010 a non-native plant management program using Sonar AS (fluridone) herbicide and AquaPro (glyphosate) herbicide was conducted at Spy Pond to control growth of non-native, invasive Eurasian watermilfoil (*Myriophyllum spicatum*) and common reed (*Phragmites australis*). The Year End Report for the 2010 Management Program follows. This report will serve to document the herbicide application process, the post-treatment monitoring of aquatic vegetation in the waterbody and the observed response of the targeted weeds. Attached to this report is supporting documentation that further helps to explain the project and the observed results.

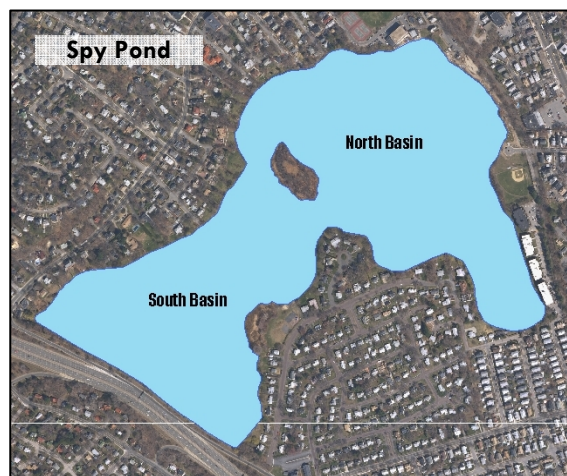
- Distribution of dense milfoil growth was reduced some by comparison to pre-treatment conditions in 2009 and was confined primarily to constricted portion of South Basin west of Elizabeth Island and to the shallow and historically infested coves (see figure right)

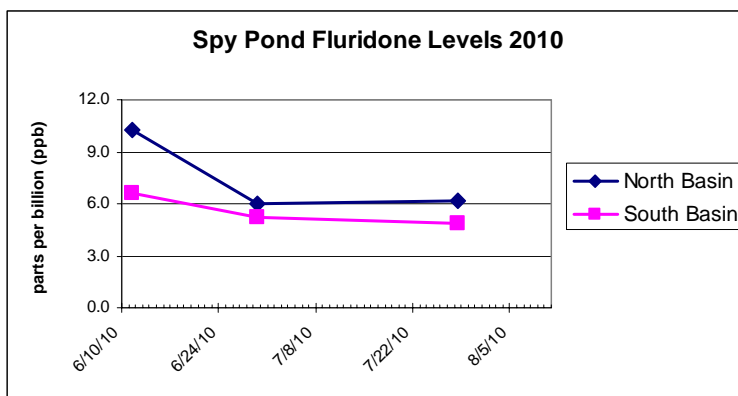
FasTEST monitoring at Spy Pond in 2010 indicated that a lethal concentration (>6 ppb) of fluridone was maintained for at least 60 days. The average lake-wide concentration of fluridone was 6.5 ppb from 6/11 to 7/28/2010.

A second “booster” application of Sonar was scheduled and performed on July 7th. Timing of the second application was guided by the collection of FasTEST samples that were analyzed by the SePRO Laboratory (the manufacturer of Sonar). Samples were periodically collected throughout the course of the treatment to monitor in-water concentrations of fluridone and insure that appropriate lethal concentrations were maintained for a minimum of 45-60 days. Monitoring of fluridone concentrations is paramount to the multi-year control of milfoil often possible with fluridone treatment.

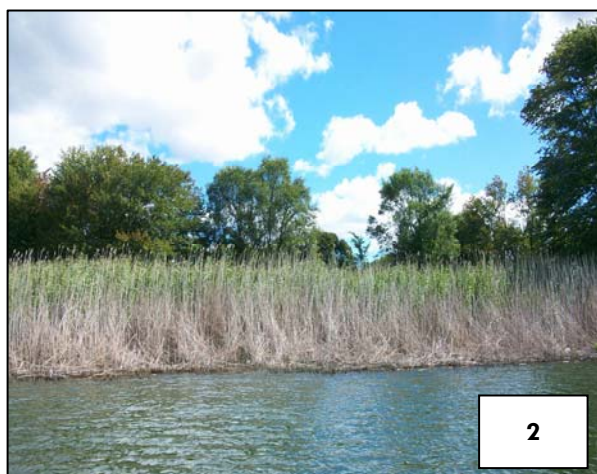
- Picture 1: Dead *Phragmites* stalks surrounded by water willow and backed by green shrubbery on Elizabeth Island - 5/4/10.
- Picture 2 : Dead “in-water” *Phragmites* with healthy “land-based” *Phragmites* behind – Kelwyn Manor Park – 5/4/10

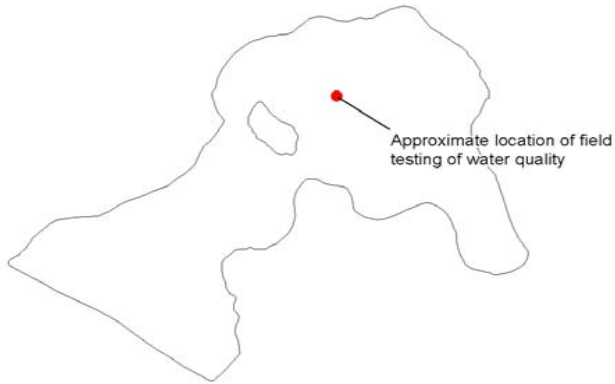
2010
Temperature/Dissolved Oxygen Profiles For Spy Pond - Arlington, MA

5/4		5/21		9/15	
Depth (m)	Temp. (C)	D.O. (mg/l)	Temp. (C)	D.O. (mg/l)	Temp. (C)	D.O. (mg/l)
Surface	18.8	10.75	18.9	8.98	20.2	8.29
1.0	18.5	10.06	18.8	8.88	20.2	8.12
2.0	14.9	11.16	17.4	8.95	20.2	8.10
3.0	13.7	11.67	16.7	9.04	20.2	7.66
4.0	13.1	11.67	16.4	8.76	20.1	7.65
5.0	12.0	11.81	16.4	8.88	20.0	7.71
6.0	10.7	11.76	13.9	8.94	19.8	7.16
7.0	8.4	9.65	12.4	9.47	18.0	0.56
8.0			9.2	9.38	14.4	0.57
9.0			8.1	7.01	12.4	0.57
10.0					10.2	0.59
